## Suggestions for better tip-offs and more reliable units.

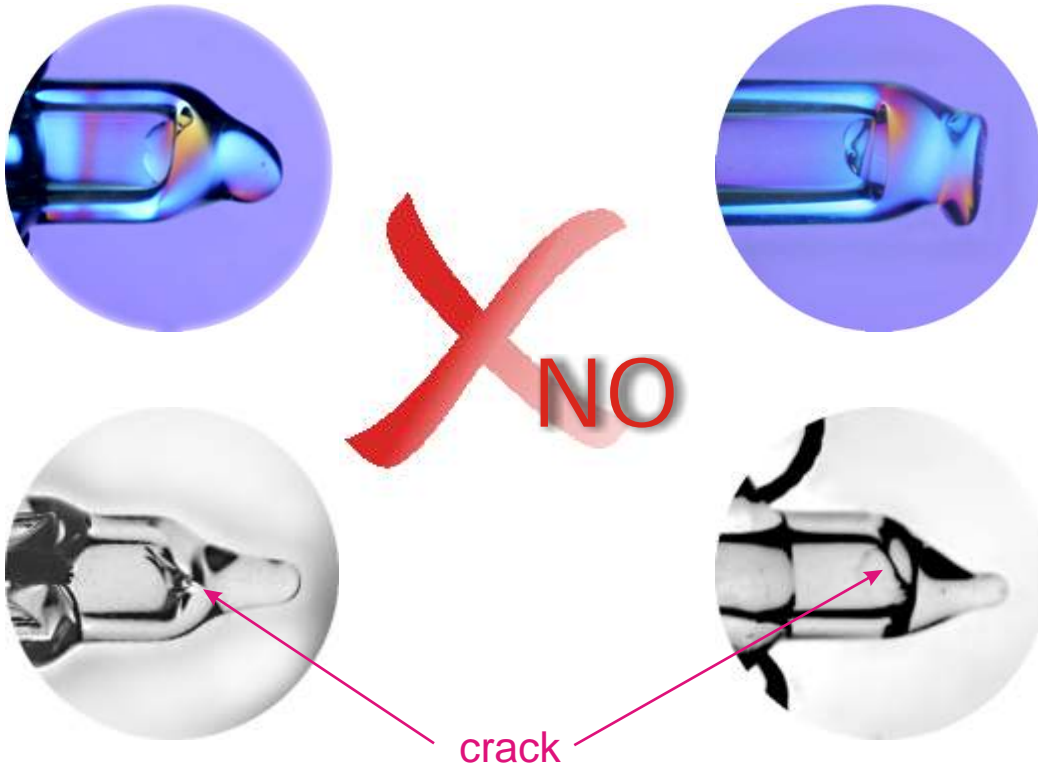
After time the stress can cause cracks as in the pictures

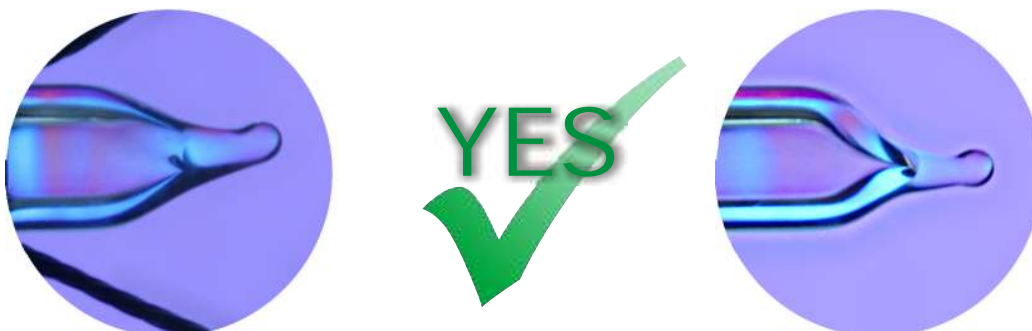
For reliable units, the tip-off should look like those below. Notice that there are no yellow indications of stress under the polariscope.:
